Fire resistance of extruded hollow-core slabs

Published in:
Journal of Structural Fire Engineering

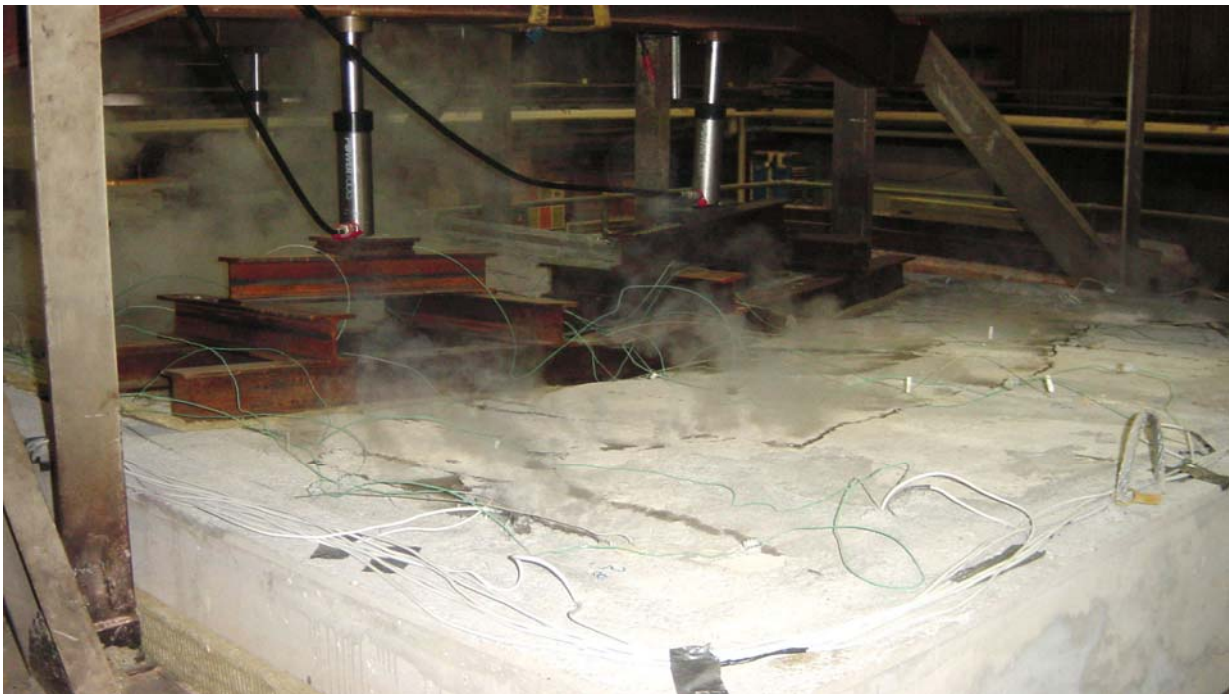
Figure 7. Cracks in top flange after approx. 15 min. Photo K. Hertz.

The midspan deflections are given in Figure 6. Substantial cracks were developed in top and bottom of the slab elements after 15 minutes (Figure 7), and the ISO 834 standard fire duration was assessed to be 25 minutes at this accredited test.

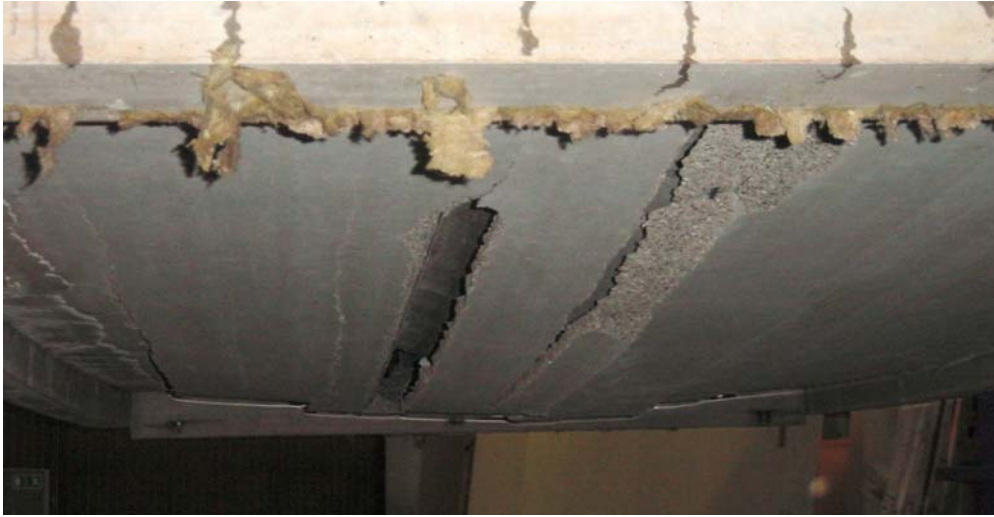
Figure 8. Damages after 25 minutes. Photo K. Hertz.

Lifting the element off the oven, it was seen that the bottom flange was partly fallen down and large cracks were developed to the other channels (Figure 8). No sign of shear failure was seen and the deflection indicated that the failure mode may have been bending. But as explained in the following, the failure modes of shear, anchorage, bending, and de-lamination may be results of the same deterioration of the slab.

Cracks appear along the decks under the channels after 10-15 minutes fire exposure and often the bottom flanges falls down, as shown for example in Figure 8.
